**Development of a CFRP System to Provide Continuity in Existing  
Reinforced Concrete Buildings Vulnerable to Progressive Collapse**

**Dissertation**

The University of Texas at Austin

**August 2007**

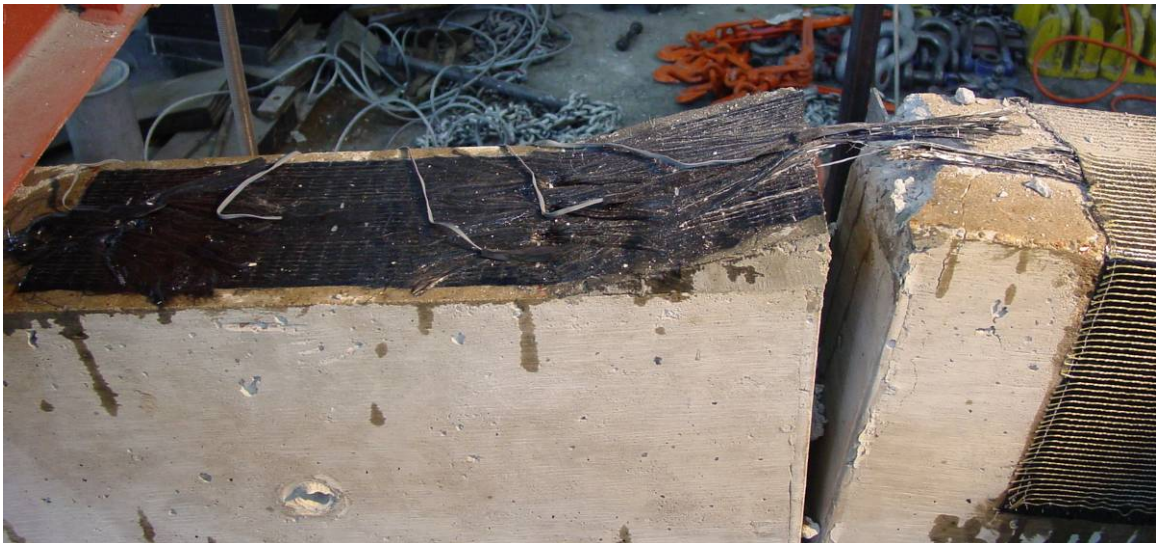
After Testing: Failure by FRP fracture

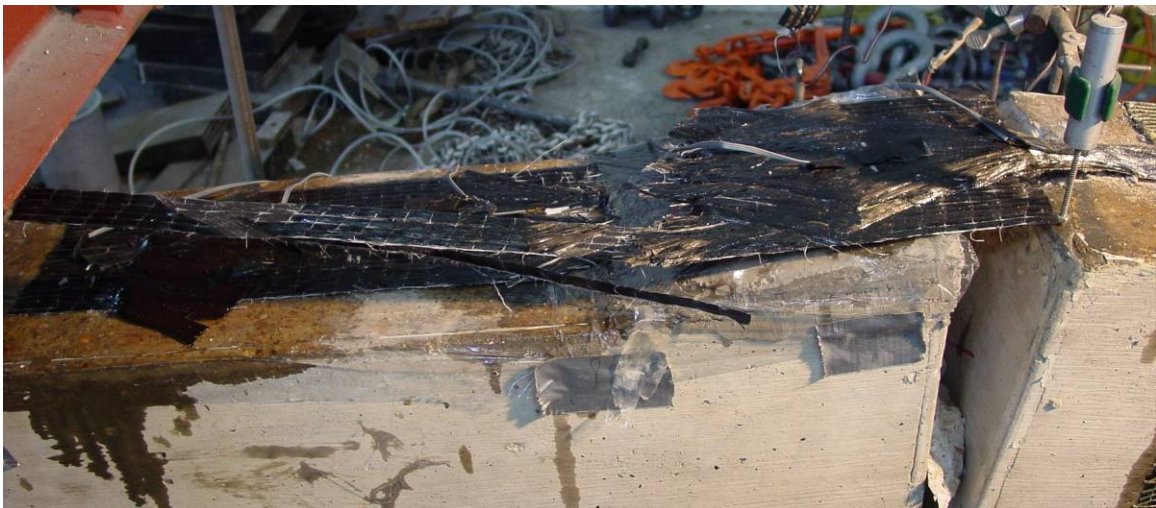
After Testing: Failure by FRP fracture

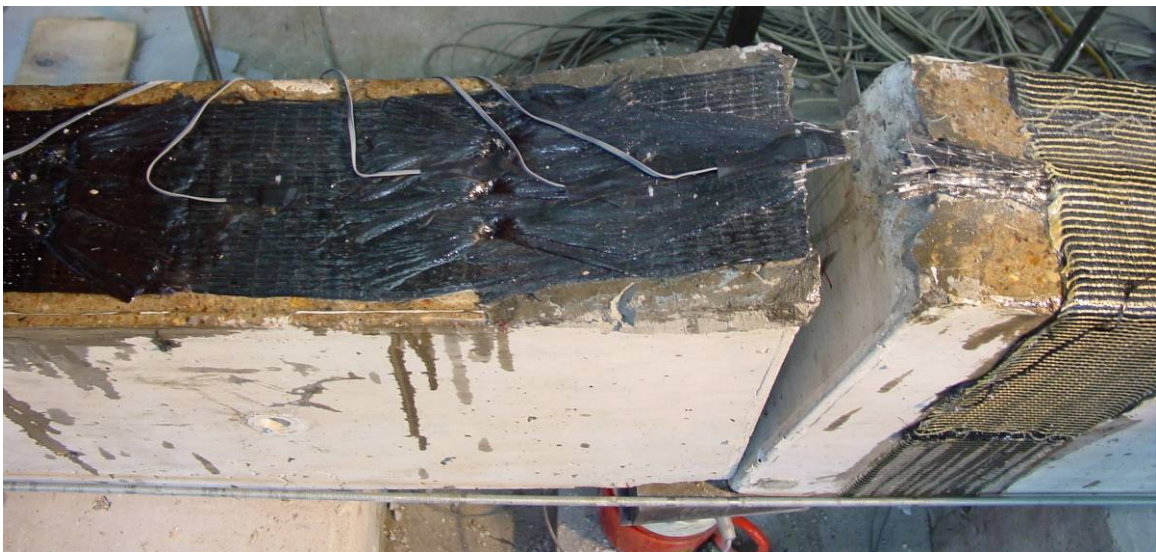
After Testing: Failure by FRP fracture

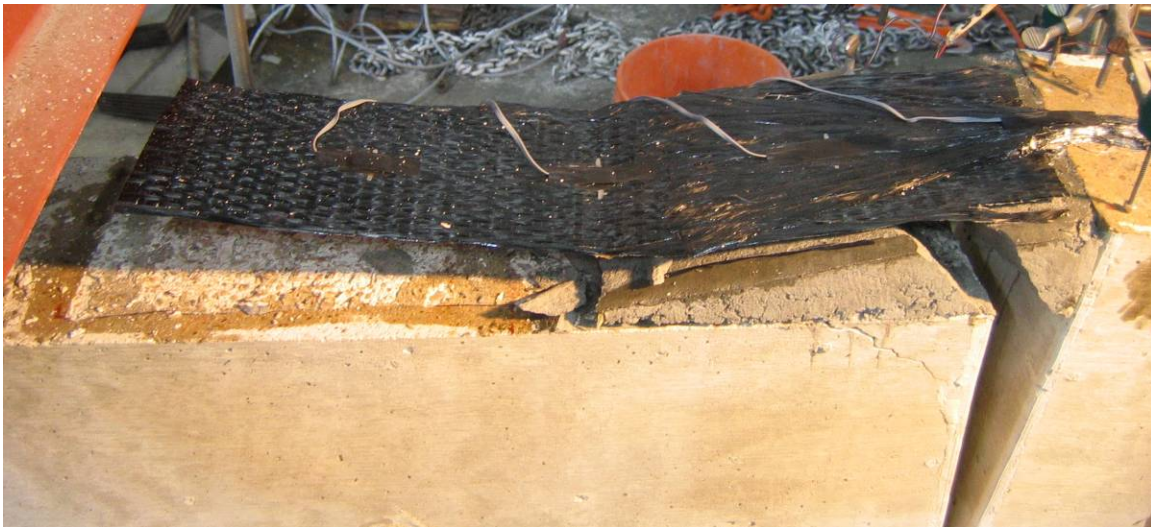
After Testing: Failure by debonding

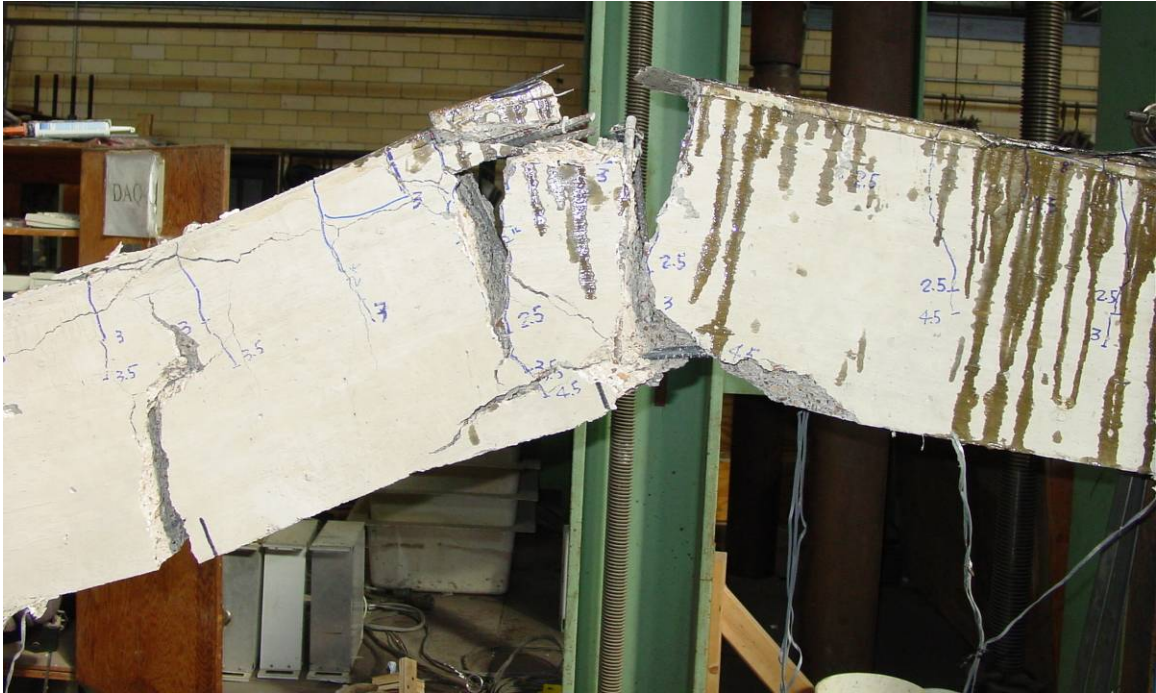
Rebar fracture
